**SITUATION REPORT
INCIDENT COMMAND POST GOLD KING
GOLD KING MINE RELEASE INCIDENT
U.S. ENVIRONMENTAL PROTECTION AGENCY**

Subject: EXECSUM / SITREP #46
Gold King Mine Release Incident
San Juan County, Colorado
Latitude: 37.8945 Longitude: -107.6384

From: Situation Unit, Incident Command Post Gold King
Date: 20 October 2015
Reporting Period: 0700 13 October 2015 through 0700 20 October 2015
Website: www.epa.gov/goldkingmine

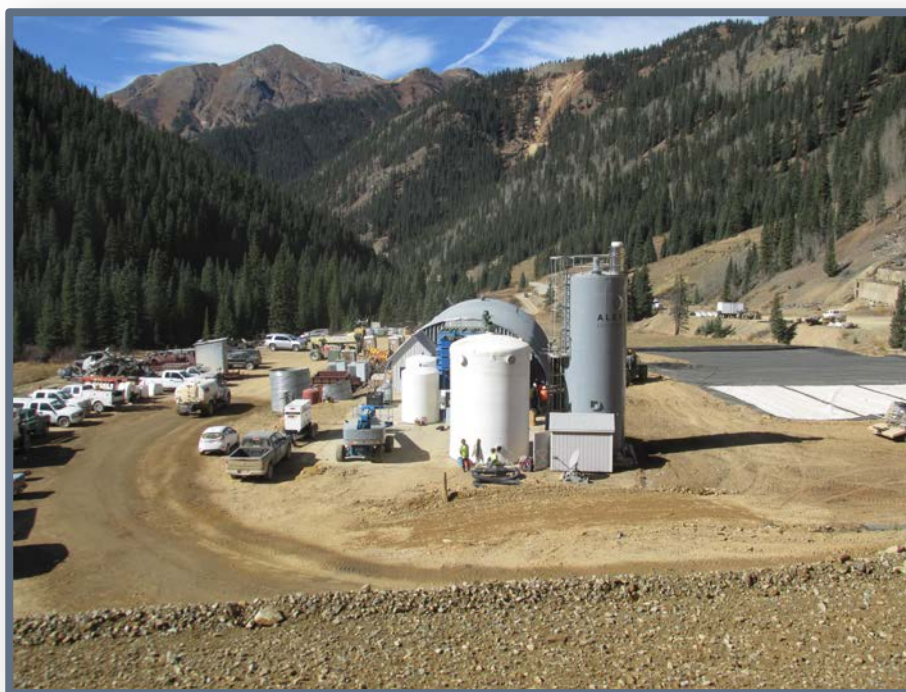
Construction activities on water treatment system and tiered solid dewatering pad (15 October 2015)

- Mine Operations
 - Continue management of mine water discharge.
 - Completed installation of the modular water treatment system and tiered solid de-watering pad. System was put into operation on 18 October 2015 and is currently operating 24 hours per day.

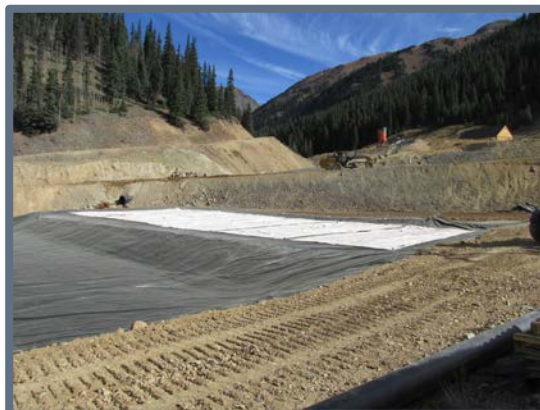
Construction activities at Gladstone tiered solid dewatering pad. First row of Geotubes visible on upper tier of dewatering pad (15 October 2015).

- As of 15 October 2015, water from Gold King Mine was being routed directly to Gladstone.
- On 17 October 2015, water flow commenced from Gladstone to the water treatment system.
- As of 18 October 2015, the water treatment system was reported as being fully operational. Additionally, the tiered solid dewatering pad (Geotube Area) was operational.
